# 4-Point Inspection Form

Address Inspected: \_\_\_\_\_

Actual Year Built: 1986

Date Inspected: 08/15/2020

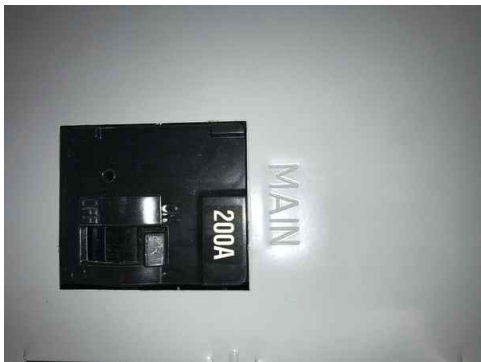
Total Amps: 200

200A

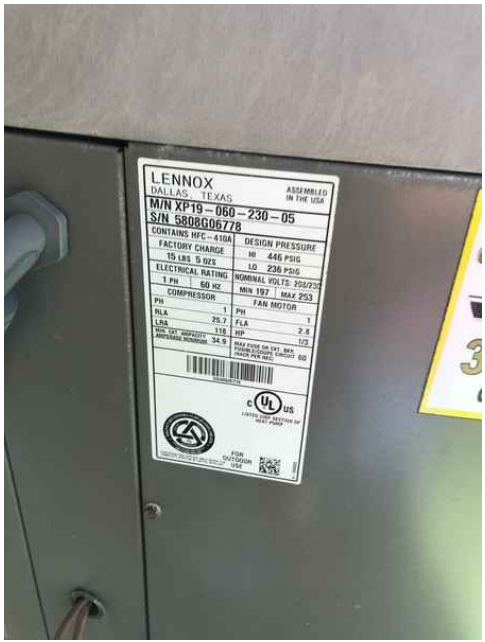
Mfg Plate 2008

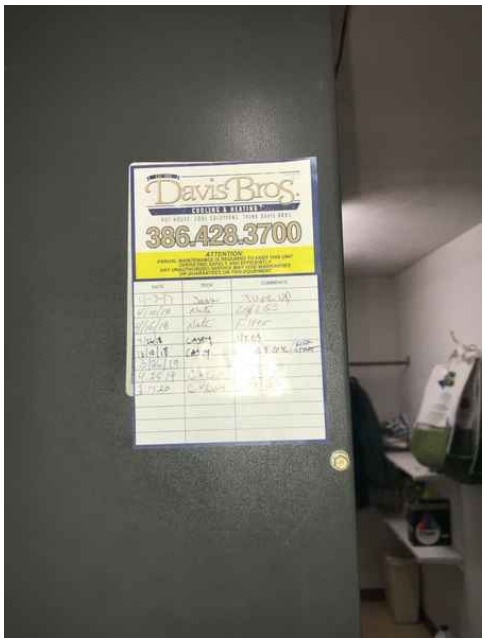
Date of last HVAC servicing/inspection: 2020-03-17

Serviced 3-17-2020

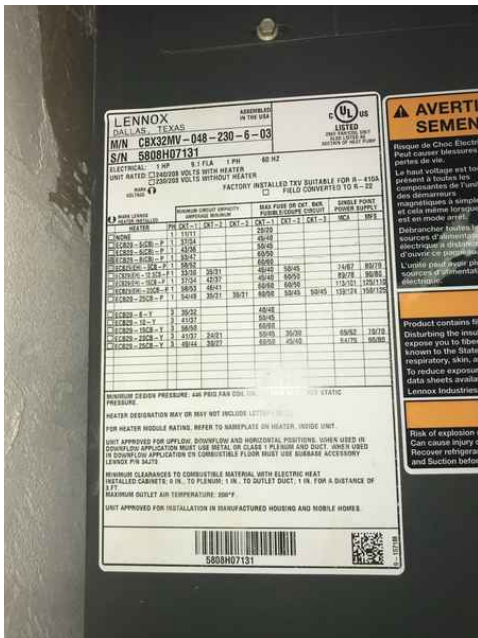
Year last updated: 2008

Mfg Plate 2008

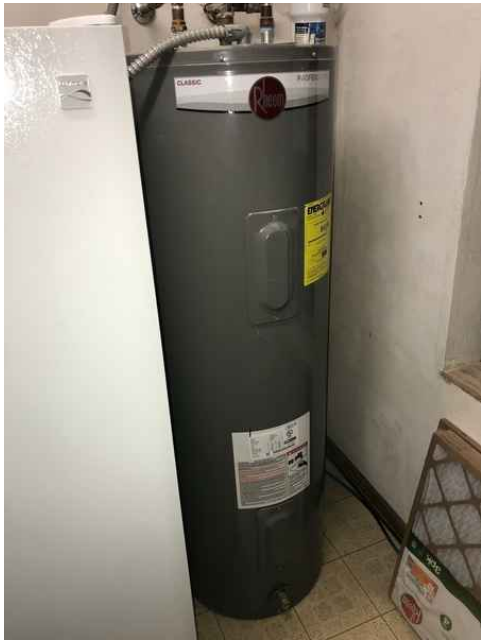
Rheem-No Drip Pan

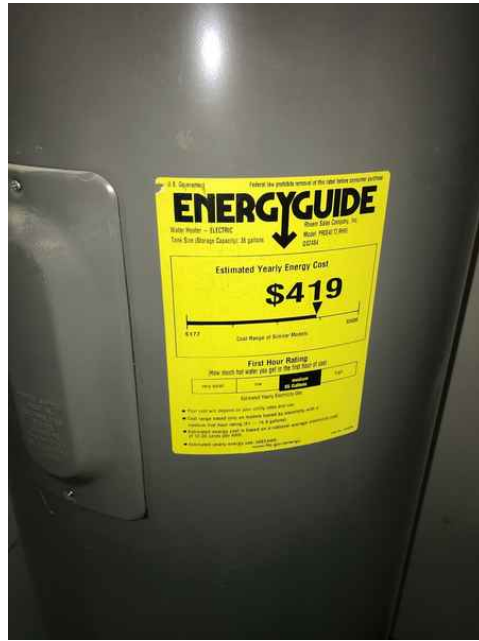
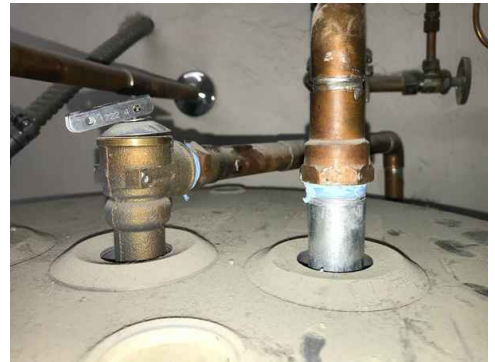
TPR Valve With Drain Line

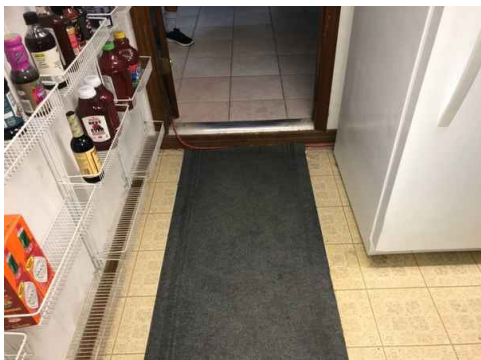
Hot water tank is located in the washer room that sits approx 4" below the main home foundation. The wash room is on the same level as the garage. Roofing permit #17-725 March 3, 2017. Secondary roof is non living screened patio.

Approx 4" drop off to wash room

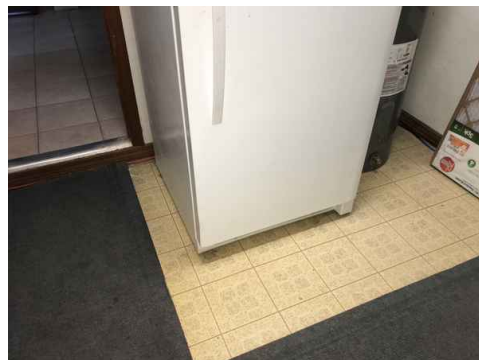
Hot water tank sits below the main house foundation
