OCEANSIDE INSPECTIONS

AUGUST 13, 2020

Inspector Dustin Bruno HI-11511 386-290-9777 osi.dustin@gmail.com

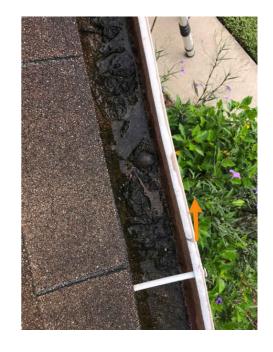
2.2.1 Roof Drainage Systems

DEBRIS

Debris has accumulated in the gutters. Recommend cleaning to facilitate water flow.

Recommendation

Contact a qualified roofing professional.

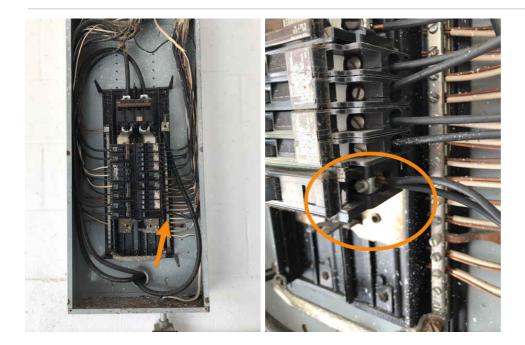
4.2.1 Main & Subpanels, Service & Grounding, Main Overcurrent Device

DOUBLE TAP

Double tap present at the time of inspection

Recommendation

Contact a qualified electrical contractor.

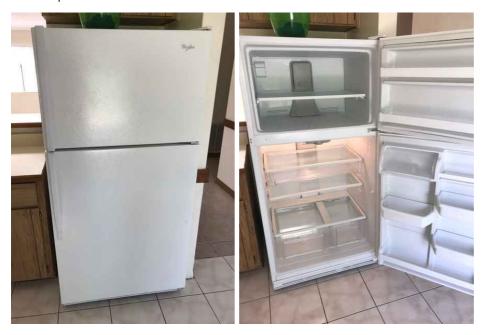
Refrigerator: Brand

Whirlpool

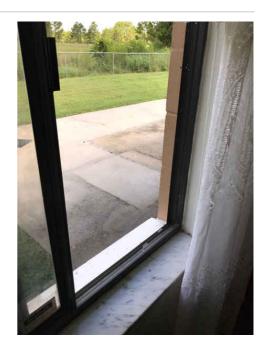
6.3.1 Windows

MISSING SCREEN

Window missing screen. Recommend replacement.

Recommendation

Contact a qualified window repair/installation contractor.

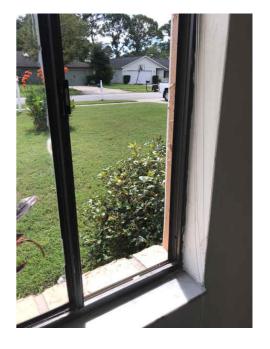
8.3.2 Windows

MISSING SCREEN

Window missing screen. Recommend replacement.

Recommendation

Contact a qualified window repair/installation contractor.

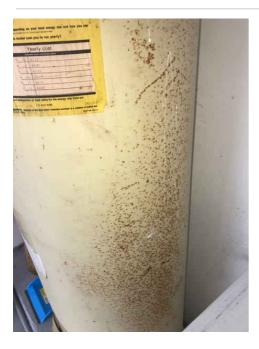
12.4.1 Hot Water Systems, Controls, Flues & Vents

CORROSION

Corrosion was noted at the pipe fittings or exterior. Recommend a qualified plumber evaluate for repair/replacement.

Recommendation

Contact a qualified plumbing contractor.

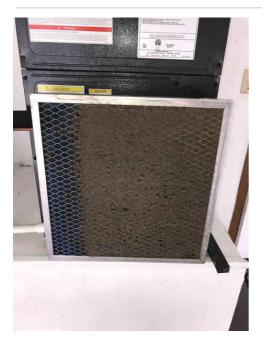
13.2.1 Heating Equipment

FILTER DIRTY

The furnace filter is dirty and needs to be replaced every 30 days or per manufacture.

Recommendation

Contact a qualified HVAC professional.
